Project: NRG Reinforced Concrete Chimney Repair

Confinement and Concrete Deterioration Prevention

Location: San Francisco, CA

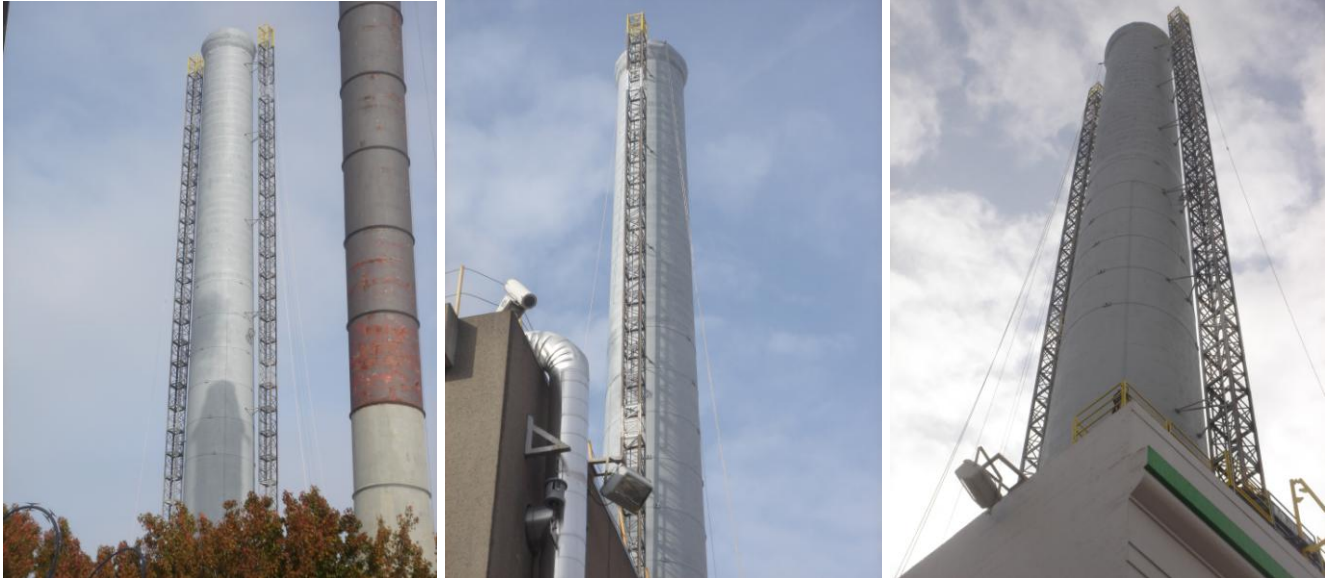
Stack deterioration was noticed during a 2008 visual observation from ground level by the facility staff. The initial investigation noted that there were cracks and exposed rebar at the upper levels of the stack. Although there were no reported incidents of material falling, staff and public safety became a concern.

A more detailed inspection revealed that the upper portion of the stack showed the most severe deterioration however the condition rapidly improved as the inspection moved lower. Several repair schemes were presented to provide different levels of repair ranging from doing nothing and continuing to monitor the stack for further deterioration to removal and replacement of the deteriorated section.

The Fibrwrap option, consisting of application of one vertical layer and one horizontal layer of the Tyfo® SCH (carbon) System to the exterior of the deteriorated portion of the stack, was selected based on the overall benefit and value provided to the stack. The Fibrwrap System was applied to the top 75 feet of the stack over the course of five days by crews working double shifts in order to complete the project on time.
