Project: Bank of America Parking Deck

PT-Beam Repair

Location: Charlotte, NC

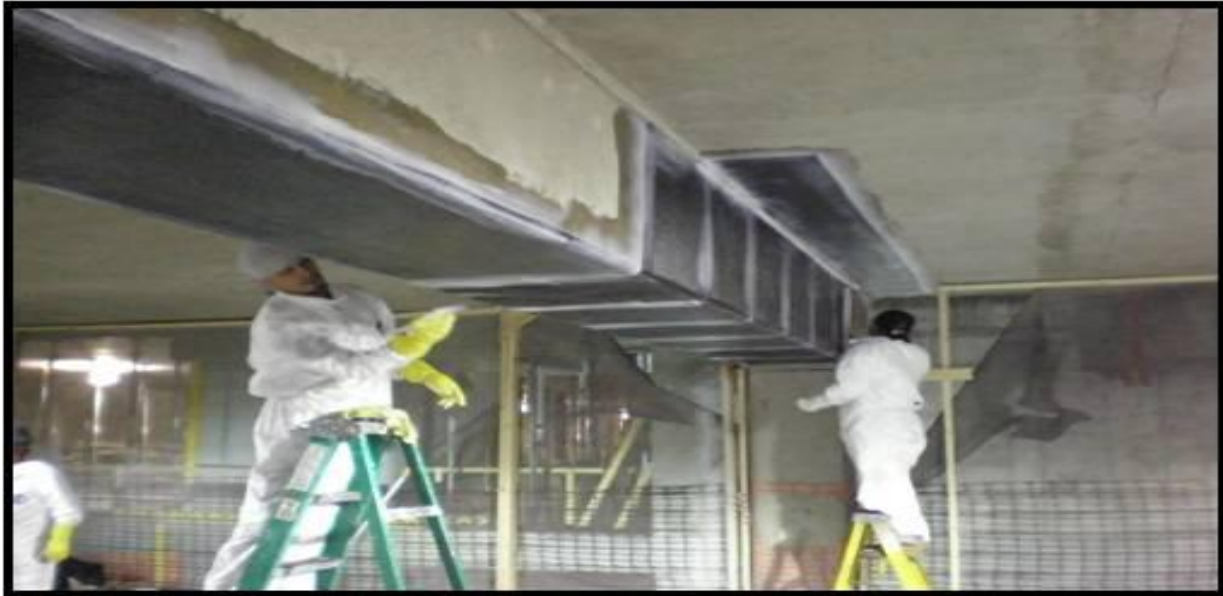
Several post-tensioned beams were damaged during the installation of new steel beam framing at various locations. The damage was in the form of broken tendons in the beams due to the drilling for the connections of the new steel beams.

The carbon-based Tyfo[®] SCH-41 Composite System was utilized to provide positive and negative bending capacity as well as shear capacity to the damaged beams. All of the reinforcement was provided below the parking slabs. Thus, all SCH-41 reinforcement was available for the application of the Tyfo[®] Advanced Fire Protection (AFP) System to provide a 2-hour fire rating to the system. The entire system was only 1" thick and did not affect the already minimal head room of the parking garage levels.
