## Project: Atlanta Underground

*Column Strengthening*

*Atlanta, GA*

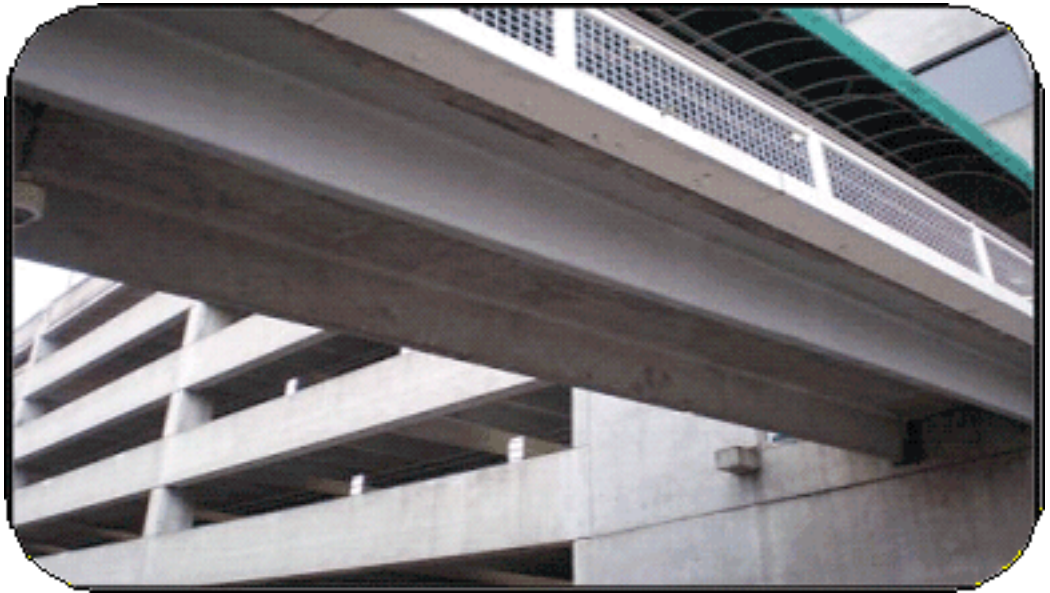
The pedestrian bridge is supported by a prestressed, double tee member. It had been struck by a truck causing extensive cracking and damage to one stem of the tee.

The damaged concrete was removed and patched, and all cracks were injected. The carbon-based Tyfo® SCH-41 Composite System was then applied to the bottom of the stem to provide flexural capacity that may have been lost from damage to the prestressing strands. The glass-based Tyfo® SEH-51A was wrapped around the stem to encase the repair. As a finish, Tyfo® A Paint was applied over the installed composites to match the concrete color.

A heavily damaged member was structurally repaired using conventional concrete repair methods coupled with a robust FRP composite design and installation.
