Project: Linn State Elevator

Wall
Strengthening

St. Louis, MI

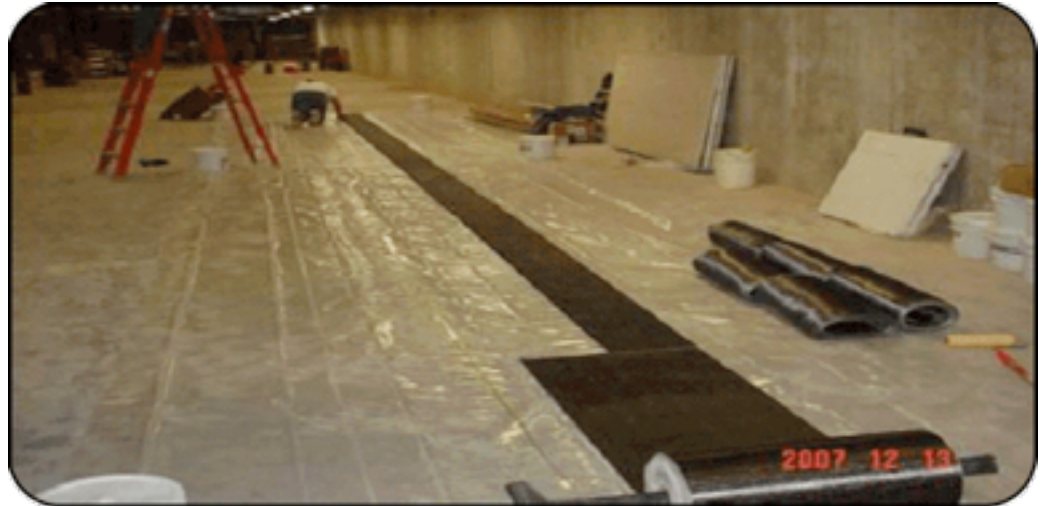
The elevator shaft was incorrectly reinforced and did not meet the requirements for wind loads, nor for FEMA missiles. The design had called for #7's at 8"o.c.; the actual construction had #7's at 16"o.c. plus the engineer was unsure if the cells were grouted.

We designed the composite to replace the missing steel. An 8" wide strip was installed for each missing rebar. The carbon composite was used with lengths of up to 45 feet applied vertically inside the elevator shaft.

The construction defect was repaired using the carbon composites. Since it was an elevator shaft, the strengthening solution could not impact on the elevator opening. The use of fiber wrap allowed a repair that had no impact on the structure utilization. This would not have been possible with another type of strengthening.
