## Project: Interstate 94 Overpass

### Column Repair

Location: Southern Wisconsin

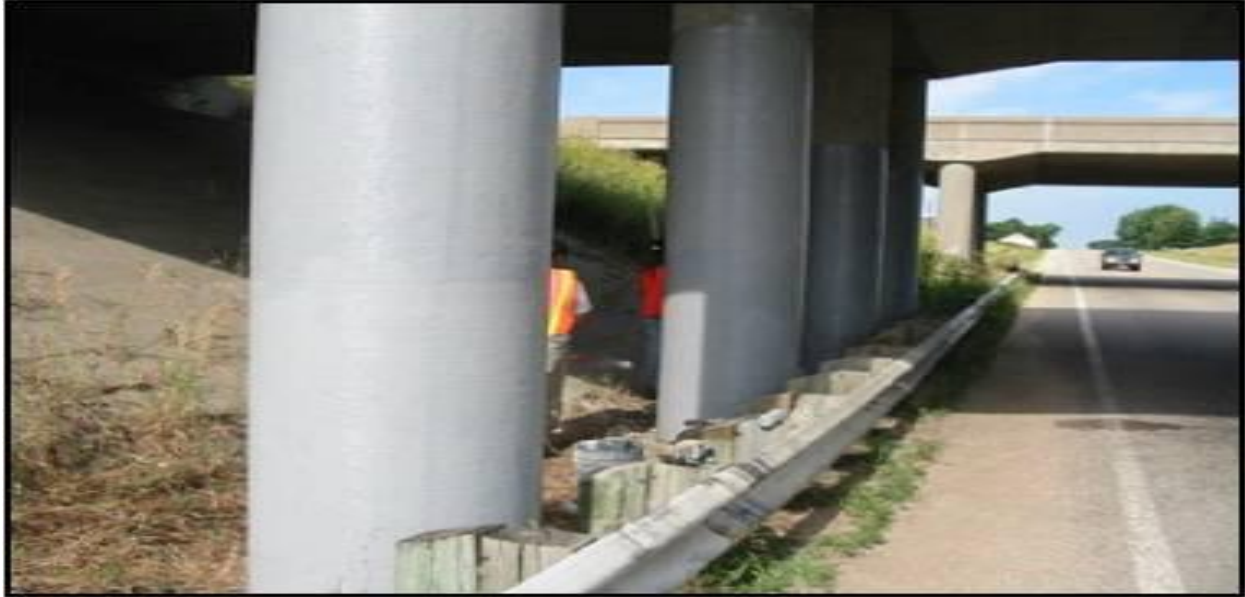
Many columns on numerous bridge overpasses showed signs of corrosion at the mid-height down to the base. The severe spalling and associated deteriorated reinforcement was mainly due to the close proximity of the columns to the busy Interstate. Constant splashing of snow and slush during the winter season enabled de-icing materials to deteriorate the concrete and reinforcement. The most severe corrosion was evident in the reinforcing ties.

Loose cover concrete was removed and the existing concrete and rebar were treated with the Tyfo<sup>®</sup> Corrosive Inhibiting Systems. The Tyfo<sup>®</sup> P Epoxy-Mortar patching material was then used to restore the original sections of the columns. Lastly, the columns were wrapped with the glass-based Tyfo<sup>®</sup> SEH-51 Composite System. The non-corrosive composite wrap provides future protection from de-icing infiltration and also provides confinement strengthening replacing the ineffective, deteriorated tie reinforcement.
