Project: ASU 90" Steel Pipe

Joint Repair

Location: Phoenix, AZ

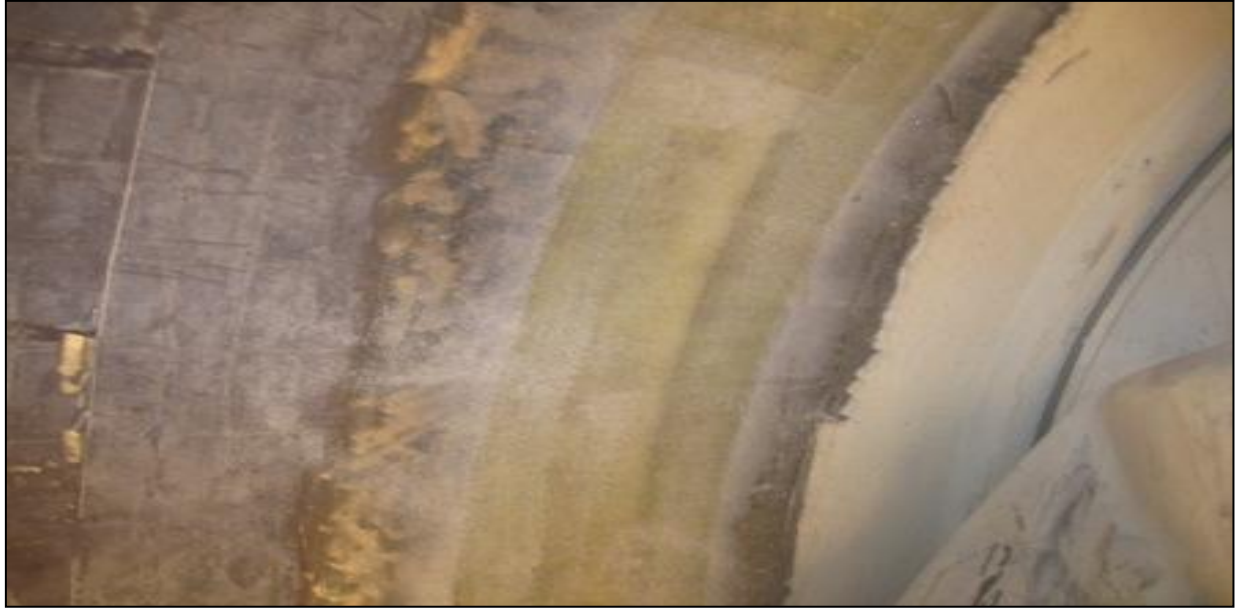
A 90-inch diameter steel pipeline in Phoenix, AZ was inoperative and in need of repair at the joint area. The pipe contained a cast iron butterfly valve with a flange joint that is 1/2" higher than the surface of the adjacent pipe and also exhibited leaks.

The mortar where the existing leak occurred was removed and provided with thickened grout to fill the gap between the flanges.

Fibrwrap® Construction then installed the Tyfo® SEH-51A System around the existing butterfly valve connection in between the adjacent pipes and filled with a thickened Tyfo® S Epoxy to smoothen and level the uneven connection.
