## Project: UCR Culver Arts Center

### Wall Strengthening

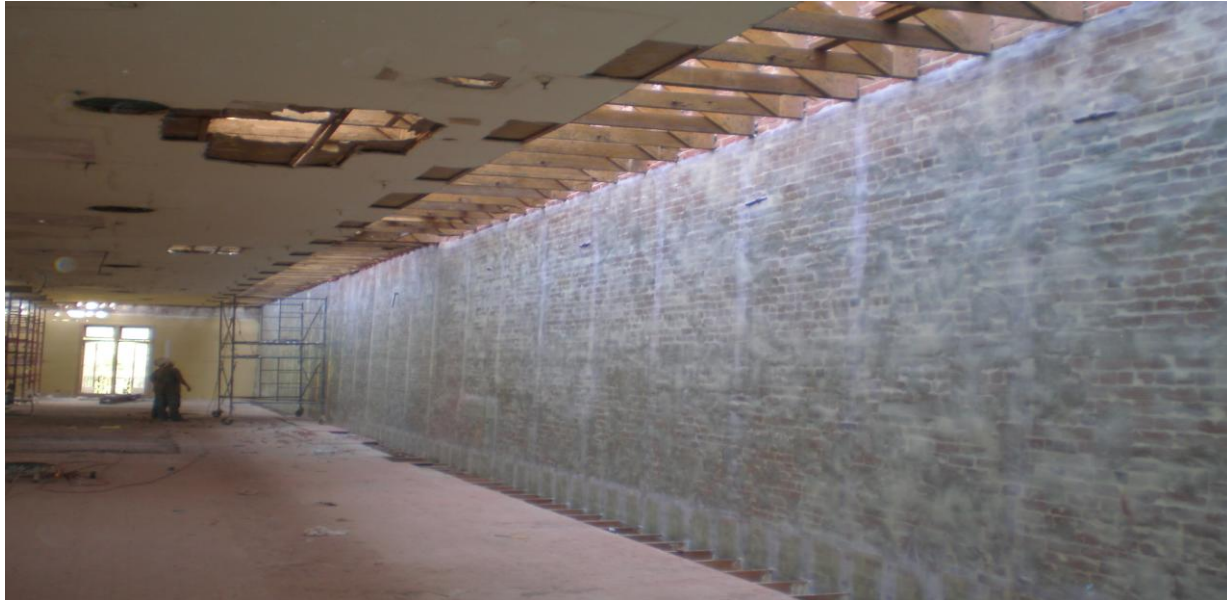
A URM and partial concrete wall section at the Culver Center of Arts in UC Riverside required additional shear strengthening due to corroded reinforcing steel and spalled concrete.

Fibrwrap<sup>®</sup> Construction, Inc. applied a concrete repair mortar to address the spalled concrete as well as the significant change in surface plane from the URM to concrete wall at a 6:1 ratio to smooth out the transition.

The glass-based Tyfo<sup>®</sup> SEH-51A was then installed both in the horizontal and vertical direction to provide the adequate required reinforcing as determined by Saiful Bouquet Structural Engineers.

The Tyfo<sup>®</sup> R&R material was applied as a finish, providing a Class 1 Flame and Smoke rating.
