## Project: Hwy 35 and 169

*Bridge Girder Repair*

Location: Twin Cities, MN

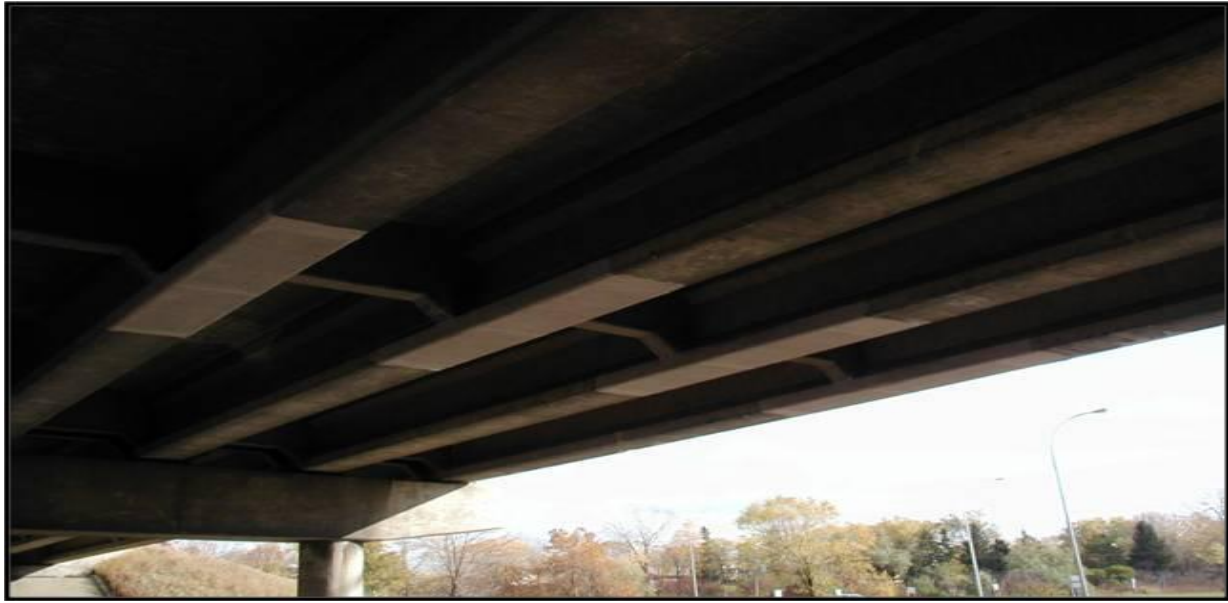
Two bridges were damaged due to impact by truck payloads in separate incidences. In both cases, the prestressed concrete girders attained minimal structural damage. However, the existing prestressing strands showed evidence of corrosion due to the exposure from the loss of concrete attained from impact.

The girders required corrosion treatment coupled with patching using the Tyfo<sup>®</sup> P Epoxy Mortar to restore the girder section. The patched areas were then wrapped with the glass-based Tyfo<sup>®</sup> SEH-51 Composite System. The composite was utilized as a "structural band-aid" over the overhead patched areas.
