Project: Home and Care Center

Floor Rehabilitation

Location: Milwaukee, WI

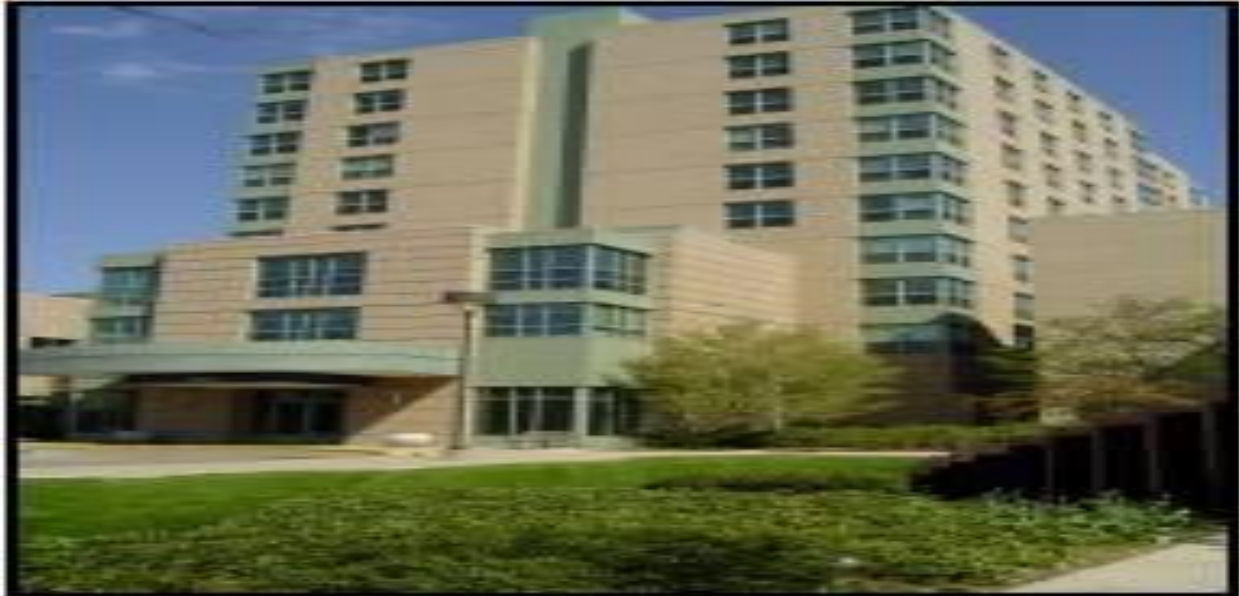
A large concrete beam and adjacent concrete joist ends were showing signs of deterioration and potential spalling. The area supported mechanical equipment that leaked water leading to the deterioration of the structure.

The mechanical equipment was removed and the carbon-based Tyfo® SCH-41 Composite System was installed at the bottom of the joist ends to provide strength to the joist ends to supplement possible corroded rebar. The fiberglass-based Tyfo® SEH-51 Composite System was then wrapped around the beam and joist ends to encase the elements and eliminate potential spalling.
