Project: Grove Isle Bridge

Bridge Rehabilitation

Location: Miami, FL

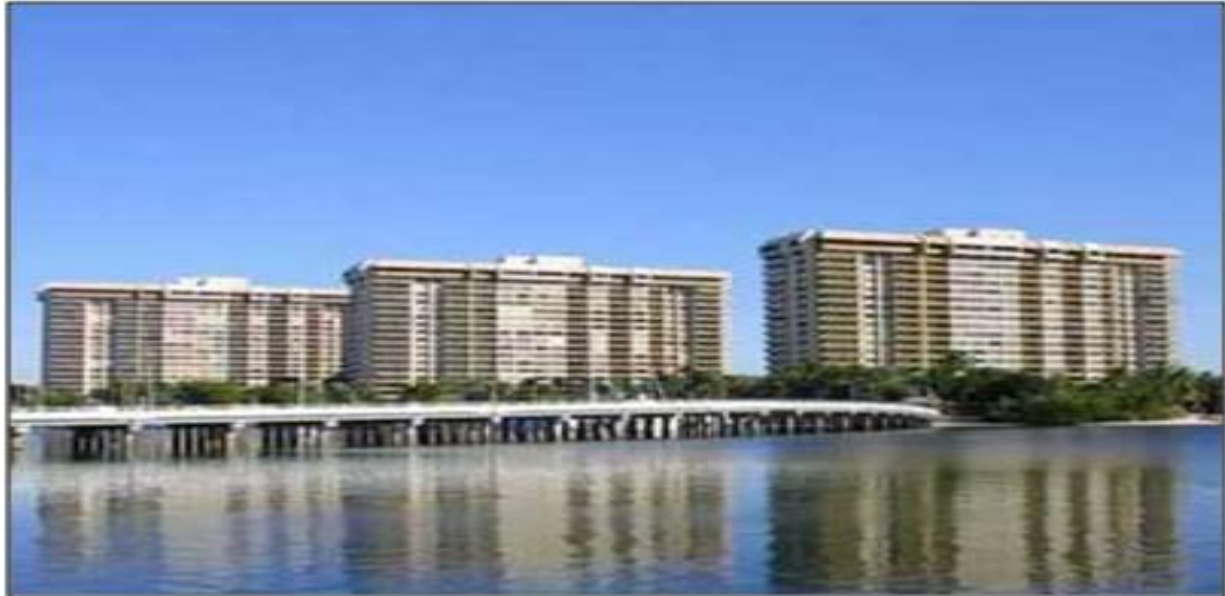
The approximately 800 foot long, privately owned concrete bridge connecting Miami and Grove Isle required extensive repair involving piles, caps and slab units as well as items above the bridge deck. The bulk of the repairs involved reinforcement treatment and concrete patching to the underside of the bridge deck slab units. In lieu of conventional hand-patching techniques at the underside of the concrete deck, a “form and pump” method was utilized. Additionally, due to the condition of the existing reinforcement, numerous deck spans required strengthening utilizing the Tyfo® SCH-41-2X System.

Many of the square concrete piles were repaired and wrapped with the Tyfo® SEH-51A System incorporating the underwater-curing Tyfo® SW-1 Epoxy. The piles were wrapped from the mud line to the deck and divers were required to install the system on 18 piles.

The project also involved crack injection, deck sealing, a new pavement approach, new lighting and barrier repair. The Grove Isle Bridge was repaired for approximately \$2.3 million within a project timeline of six months.
